Manhole Inspection Summary

Manhole # S67S__007MH

Insp Date: **3/10/08 10:34 AM**

Location Address: **1613 Pumphrey St.**

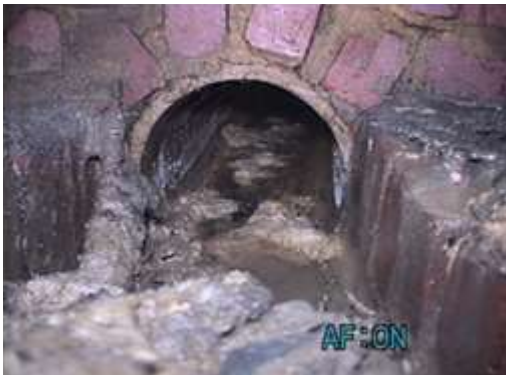
Defect 1

Cracked pipe seal 9:00-3:00 on outgoing
12 o'clock pipe

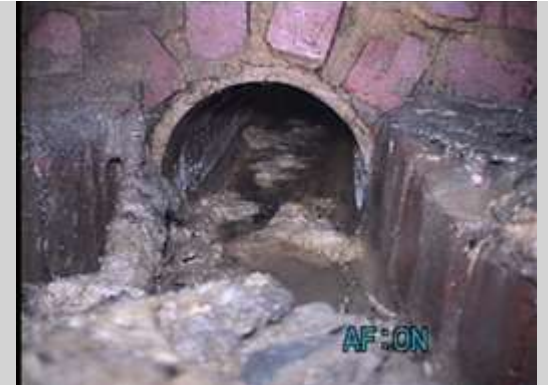
12 O'Clock Outflow

Pipe Height: **8.4** (in.) Rod and Bar (Angled)
Pipe Material: **Clay** ☐ Pipe Lined
Invert Depth: **11.25** (ft.) Flow Characteristics: **Slow**
Deposits: ☐ None ☒ **Mud** ☒ **Sludge** ☐ Debris ☐ Grease
Silt Depth: **1** (in.) Deposits Extent: **Medium**
Infiltration: **None** Pipe Seal Cond: **Sound**

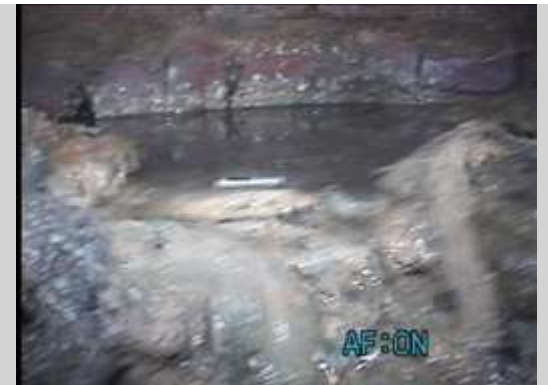
6 O'Clock Inflow

Pipe Height: **8.4** (in.) Rod and Bar (Angled)
Pipe Material: **Clay** ☐ Pipe Lined
Invert Depth: **11.13** (ft.) Flow Characteristics: **Slow**
Deposits: ☐ None ☒ **Mud** ☒ **Sludge** ☐ Debris ☐ Grease
Silt Depth: **4** (in.) Deposits Extent: **Heavy**
Infiltration: **None** Pipe Seal Cond: **Sound**
